PASSAIC RIVER BASIN
GREEN POND BROOK, MORRIS COUNTY
NEW JERSEY

PICATINNY LAKE DAM

NJ 00002

PHASE 1 INSPECTION REPORT
NATIONAL DAM SAFETY PROGRAM

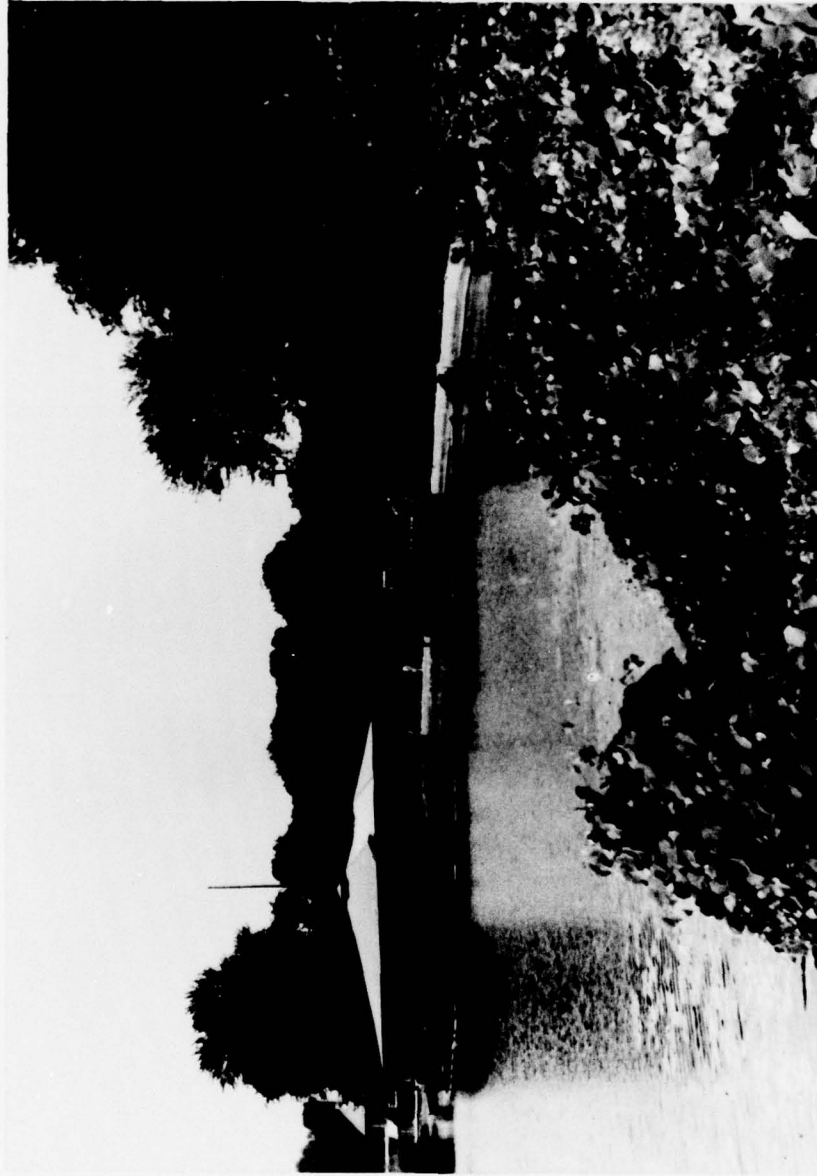
Picatinny Lake Dam
Overall view of upstream face of dam from the right.

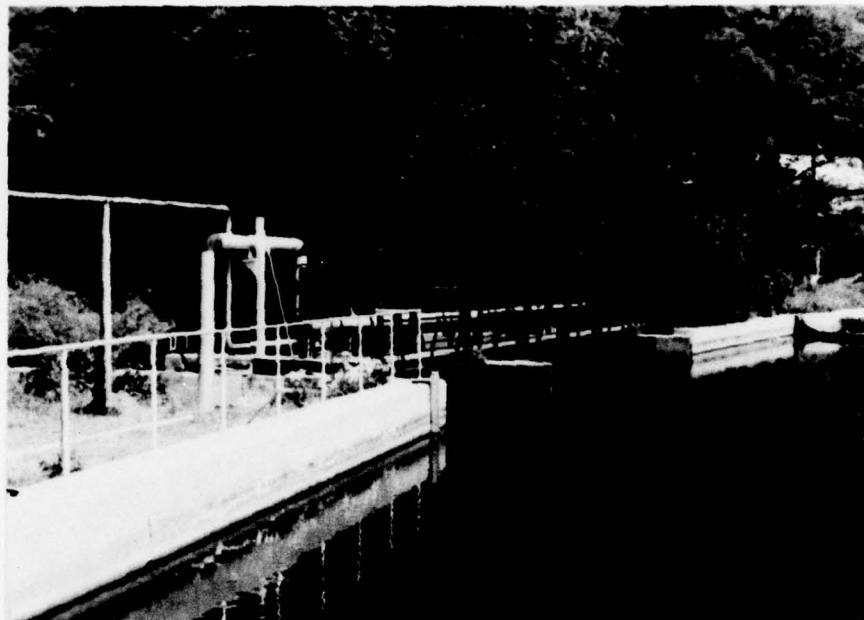
Photo No. 1 - View of upstream face of dam and spillway. Note the oil barrier, headwater gage, and the 5" ϕ steam line and 4" ϕ air line passing across the spillway. The trash/fish screens are totally deteriorated, but deterioration of the spillway structure is surficial only.

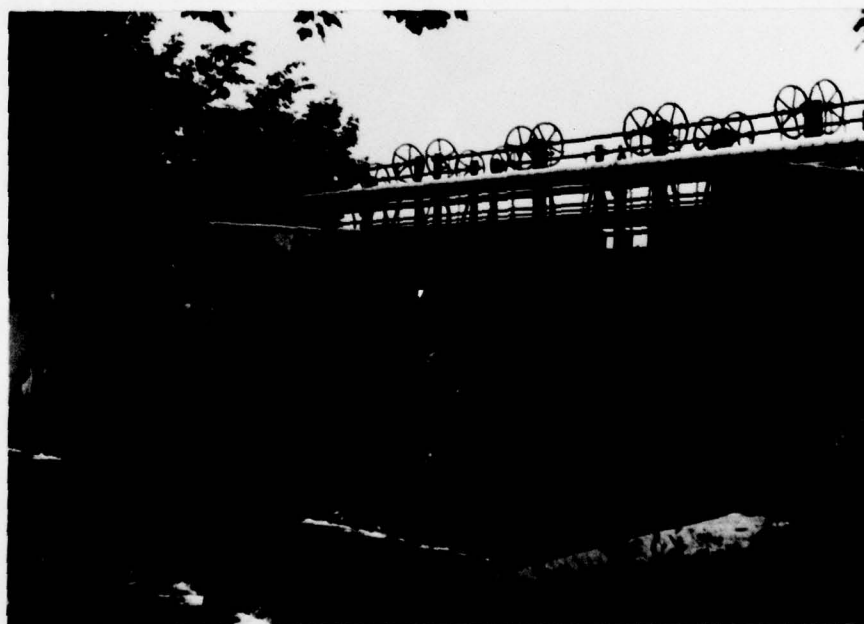
The spillway was basically in good condition. The gunnite refacing exhibited minor shrinkage cracks, a small hole (2" x 4") in the central portion of the ogee and minor erosion at the waterline. No undermining of the toe was apparent and the new masonry wingwalls were sound, apart from being slightly undermined. Flow was predominantly smooth, and was discharging mainly from the side channels. In the central section, flow was concentrated towards the left side, but this was considered to be due to the partially open flashboard and not to any significant horizontal misalignment. No low-level outlet is provided.

Photo No. 2 - View of downstream face of spillway. Note the minor deterioration on the submerged surfaces and the good overall condition.

(5) Repair all eroded, cracked and spalled concrete with epoxy cement.

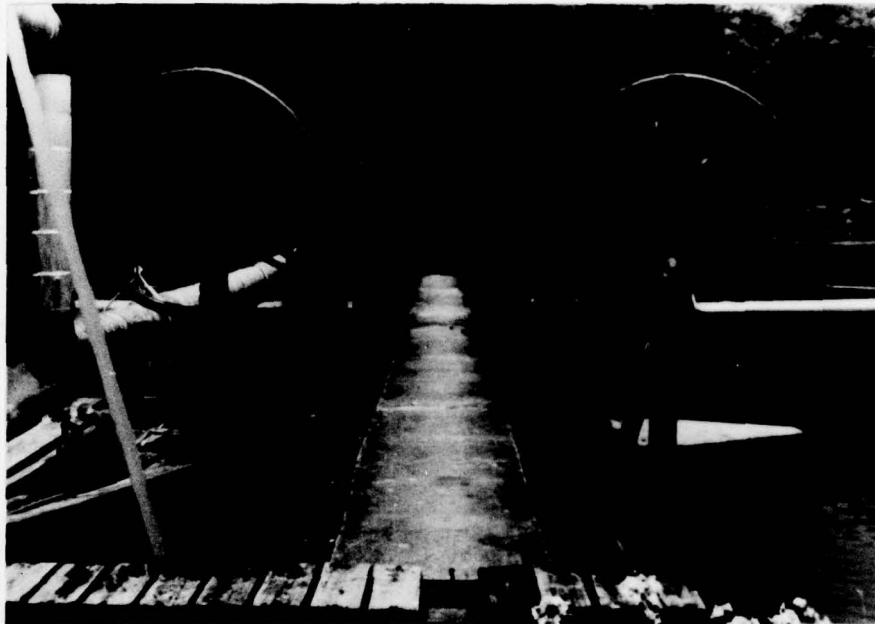
The steel and concrete foot-bridge over the spillway was found to be structurally sound. Surface rusting of the steel stringers and handrailing was noted. On the bridge piers and abutments, minor spalling of concrete was observed, and the steel protection was rusted superficially. The insulated 5" diameter steam line and the 4" diameter air-line appeared to be adequately supported and to present no hazard to the dam.

Photo No. 5 - Detail of the footbridge over the spillway showing the surface deterioration, but good structural condition. The manual lifting devices for the flashboards are to the left of the bridge, and for the fishscreens to the right.

(6) Clean and repaint all the steel-work on the spillway bridge, flashboards and operating mechanisms. Replace missing tie bars on the flashboards, and check the flashboard timbers for rot, replacing as necessary. Replace the missing lifting chain and grease all moving parts of the operating mechanism.

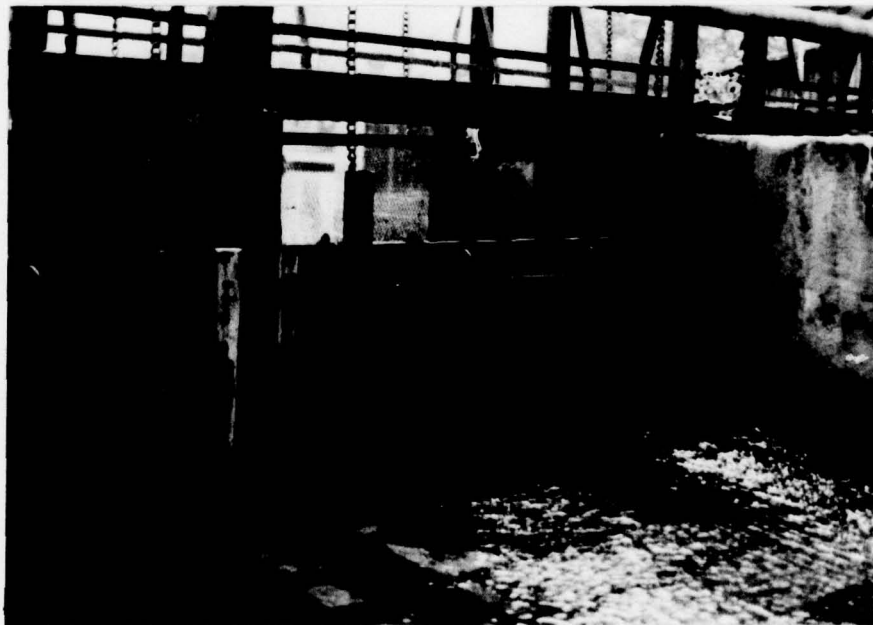
The timber spillway flashboards exhibited minor signs of rot, but this was difficult to verify. Steel reinforcement of the flashboards was rusted and some tie-rods were missing. The steel gate-guides were rusted and somewhat congested with debris, and appeared to be a tight fit.

Photo No. 6 - Typical detail of a flashboard in the center section. The flashboard shown has been raised by 1/2 inch to permit discharge from the lake. Note the missing tension rod, the rusted condition of the guides and steel gate-parts, and the spalled concrete under the footbridge.

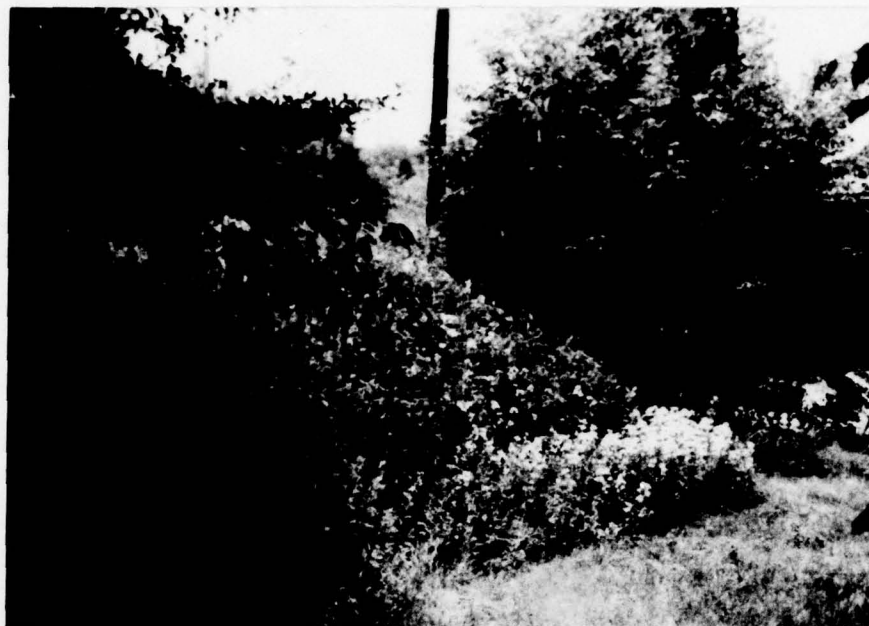
There are no signs of distress in either the earth embankments or the spillway of Picatinny Lake Dam. Horizontal and vertical alignments are good. The slope on the downstream face of 1.5H:1V is considered excessively steep, but no sign of sloughing was noted. No uncontrolled seepage was found in any part of the dam or downstream channel. The controlled drainage from above the old head-races was clear of silt, and has functioned well for 10 years. Undermining of the downstream portion of the right wingwall poses no immediate threat to stability but should be corrected in the near future. The large trees observed growing near the spillway could pose a threat to stability.

Photo No. 9 - Typical view of downstream face of embankment sloped at 1.5H:1V and covered with trees near the spillway. Note the 1" diameter airline on the right of the picture, feeding Building 333.

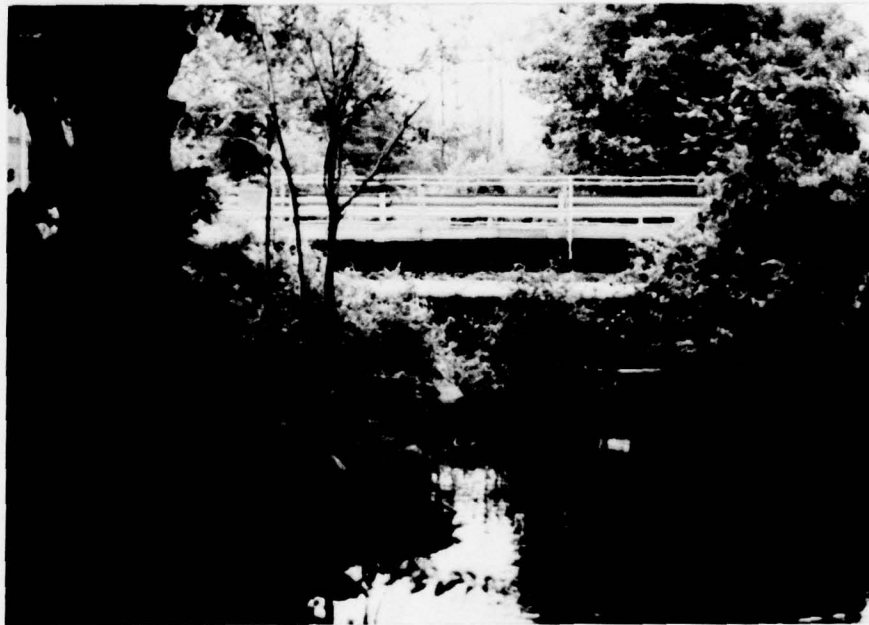
Photo No. 10- View of roadway bridge 350 feet downstream of the spillway, carrying Whittemore Avenue over Green Pond Brook. Note the steam pipe crossing the brook, and the electric cable pylon on the downstream channel bank.
